OFFICE OF EXPERIMENT STATIONS—BULLETIN 249, PART II.

THE STORAGE OF WATER FOR IRRIGATION PURPOSES—PART II.

TIMBER DAMS
AND
ROCK-FILL DAMS.

SAMUEL FORTIER,
Chief of Irrigation Investigations,

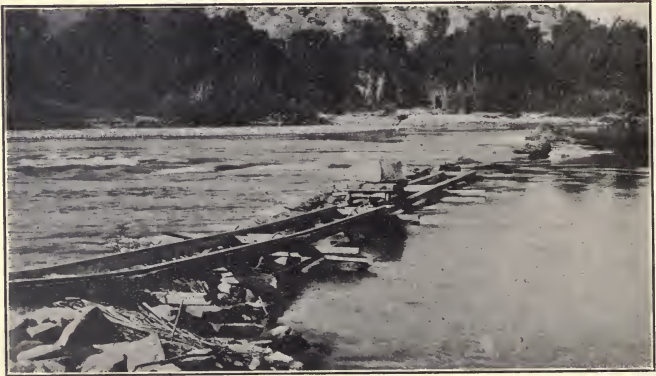
FIG. 1.—Repairing a brush dam on the Yellowstone River.

In the larger dams of this kind the brush is tied into bundles with galvanized-iron wire, these bundles being deposited in layers with the butts downstream and weighted with rock and boulders. A good example of this construction is shown in Plate I, figure 2. This dam has served for a score or more of years to divert water from the Yellowstone River into the Big Ditch, which irrigates about 25,000 acres of land near Billings, Mont. Figure 1 is a view of the same dam when it was undergoing repairs.

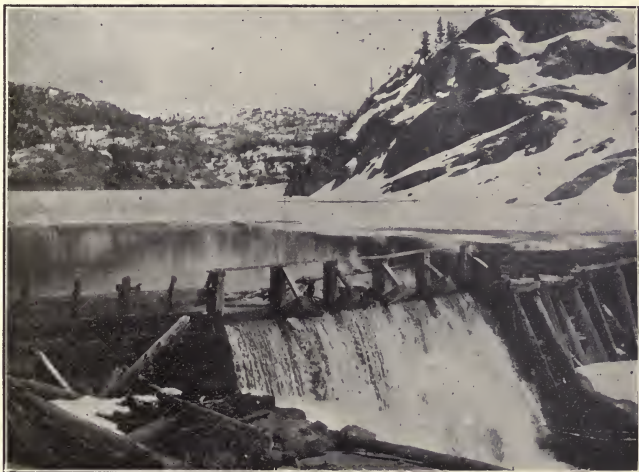
The surplus water from the reservoir flows over a spillway constructed at one end of the dam. This spillway (fig. 4) is 35 feet wide and 3 feet below the crest of the dam. It is equipped with flashboards, so that the water level of the reservoir may be varied at least 2 feet. The posts supporting the flashboards are 6 by 6 inches and spaced 7 feet centers. At times when the river is low the water is drawn from the reservoir by means of a "slum" gate, which is opened and closed by a threaded screw, at the top of which is a capstan nut operated by an iron bar. The gate slides on the upstream slope of the dam. The dam is in a bad state of repair, it being difficult to renew any part, owing to the decayed condition of the wood.

FIG. 4.—Spillway, Big Dam, South Fork Stanislaus River, Cal.

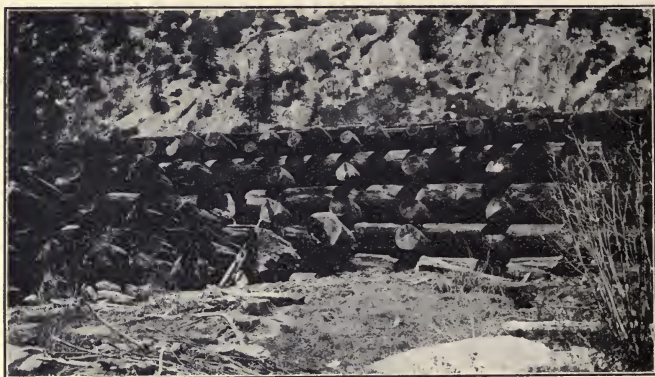
This dam is located 10 miles below Big Dam on the same river. Its structure is the same as Big Dam, being of the continuous crib type. (Fig. 5.) The dam was originally 650 feet long, but about 300 feet was abandoned and in its place a small earth-fill dam was constructed. The portion of the cribwork remaining was retimbered where it had become rotted and two thicknesses of 2 by 12 inch planking were placed on the upper slope. (Pl. III, fig. 1.) The abandoned portion of the dam and the manner in which the logs were placed are shown in figure 6. In the fall of 1907 a new apron was placed in the wasteway, the old apron having rotted out. (Pl. III, fig. 2.) The floor of the apron was built of 4 by 12 inch planks and the uprights are 4 by 6 inch, against which flashboards are placed to vary the water level of the lake. The manner of placing the logs

FIG. 5.—Middle Dam, South Fork Stanislaus River, Cal., showing manner of laying logs from the reservoir site. The site was not thoroughly cleared, however, only the best timber suitable for the construction of the dam being used. This standing timber is rotting at the water's edge and

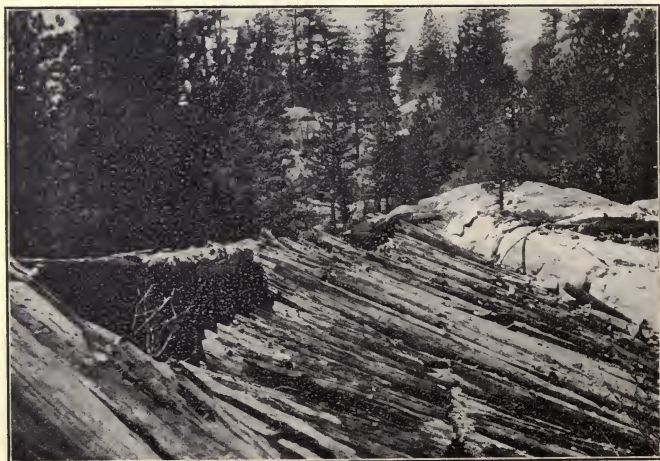
in the cribs and the notching of one on another has been shown in figure 6. The timber used in the construction of this dam was taken

FIG. 6.—Abandoned portion of Middle Dam, illustrating the placing of logs on upstream slope of continuous-crib dams.

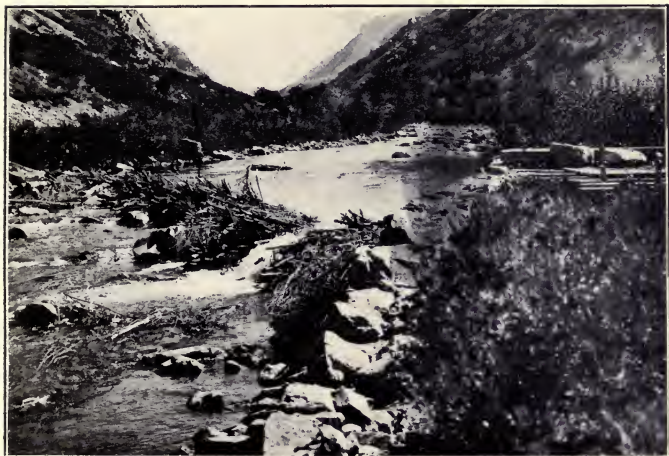
FIG. 1.—BRUSH DAM, WEBER RIVER, UTAH.

From the use of a small mat, weighted with rock, placed in creeks and small streams, the practice grew to include the damming up of some fairly large rivers for diversion purposes. A brush dam of the old type is shown in Plate I, figure 1. For 20 years or more this cheap weir and its predecessors, that were carried by floods into Great Salt Lake, served to divert water from Weber River, Utah, into the Davis and Weber Counties Canal.

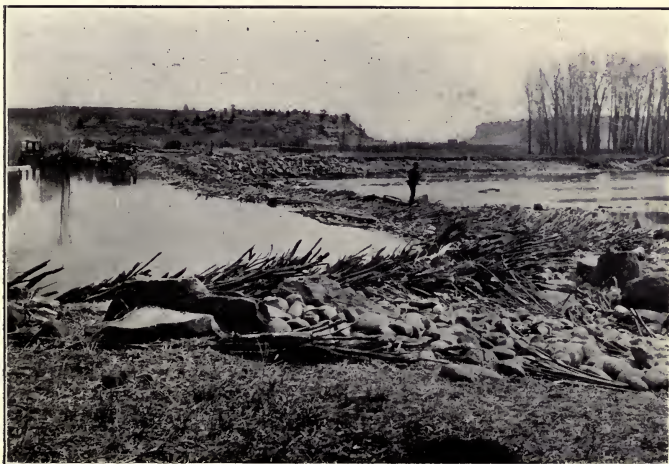
FIG. 2.—A BRUSH DAM ON THE YELLOWSTONE RIVER.

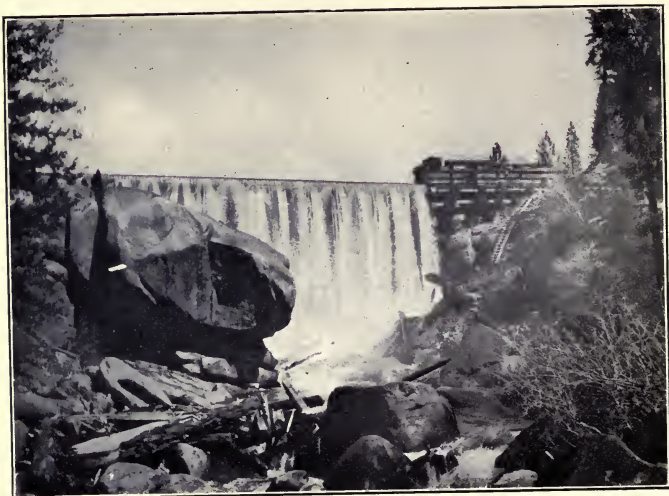
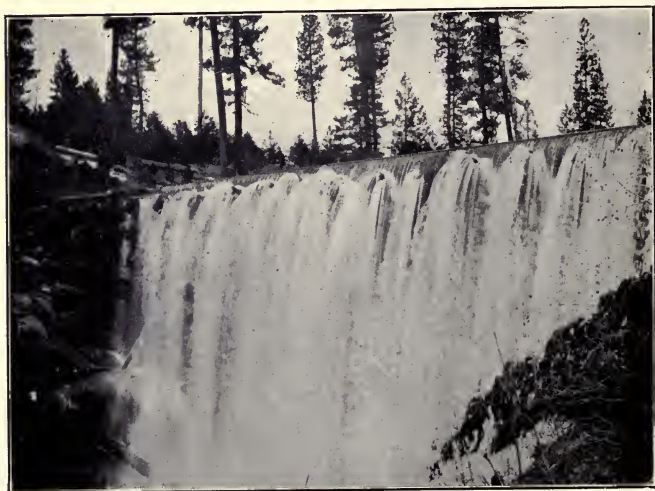
FIG. 1.—LYONS DAM, SOUTH FORK STANISLAUS RIVER, CAL.

FIG. 2.—LYONS DAM, ANOTHER VIEW.

This dam (Pl. IV, figs. 1 and 2) is the fourth of the series and completes the chain of reservoirs belonging to the Tuolumne Water Co. It was constructed in 1896-97, after plans and specifications prepared by the consulting engineer. The contract called for \$17,000, but with extras the actual cost of building was \$21,000. A plan and elevation of this dam are shown in figure 9.

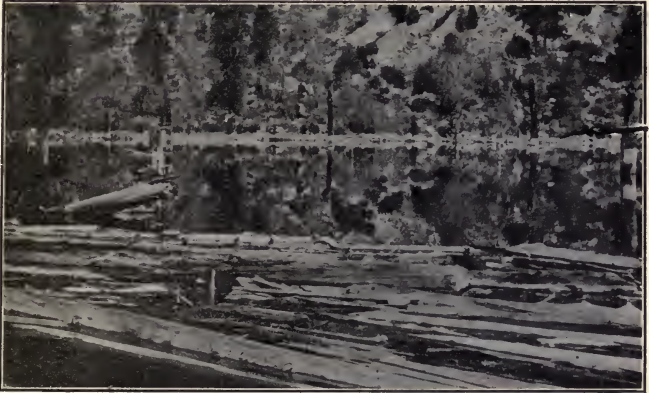
improper connections between the logs the boom broke. Figure 7 shows the result.

FIG. 7.—Débris gathered at Middle Dam, Tuolumne Water Co., Cal.

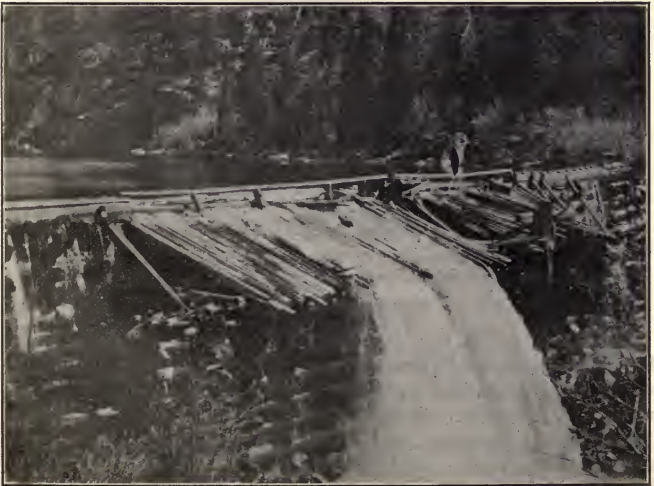
FIG. 8.—Lower Strawberry Dam, South Fork Stanislaus River, Cal.

The dam is 320 feet long and 35 feet high and is a continuous crib constructed of logs notched one on another. (Fig. 8.) A storage

reservoir is formed by it which has a capacity of 1,183 acre-feet, which is equivalent to a continuous flow of about 40 cubic feet per second for 15 days. The spillway is 104 feet wide, with a log apron 20 feet wide, built of logs 8 to 10 inches in diameter. The foundation of the dam is similar to that of the two dams previously described, and the cribwork is carried up in the same manner.

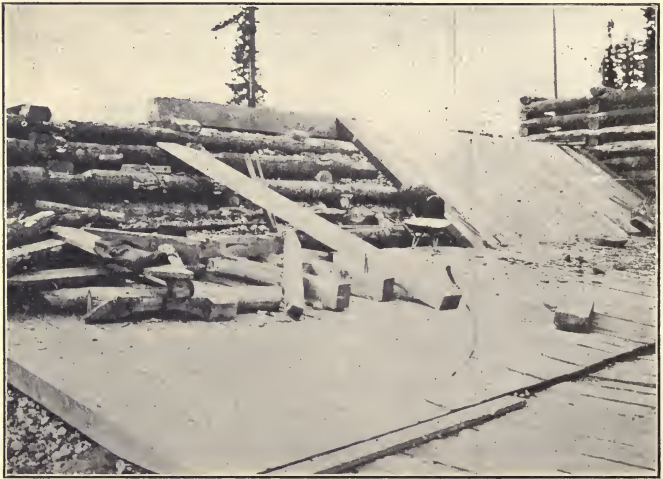
FIG. 12.—Lake Keechelus Dam, apron and spillway under construction, crest log in place and apron completed on east end.

and a clay and gravel embankment with a slope of 2 to 1 was placed on the upstream side of the cribbing. The surface of this embankment was then paved with hand-placed riprap. The cribbing on the downstream side (Pl. VI, fig. 1) was constructed so that the logs were on a $1\frac{1}{2}$ to 1 slope for the upper 12 feet (horizontal measurement), and then a slope of 6 to 1 for the next 12 feet. The latter slope breaks onto the apron, which is 24 feet wide. The apron and spillway were covered with 6-inch hewed timbers with $1\frac{1}{2}$ -inch open joints and secured to the logs at every intersection with two $\frac{5}{8}$ by 13 inch drift bolts. (Fig. 12.) All holes for drift bolts were bored $\frac{1}{8}$ inch smaller than the diameter of the bolt. To bring the channel up flush with the apron a rock fill with a slope of 15 to 1 was placed at the toe of the apron and consisted of hand-placed riprap.

The cribs for the dam proper were filled with gravel and rock. The cribs for the apron were filled entirely with rock, 75 per cent of which was at least one-tenth cubic foot in volume. The outlet consists of three openings through the bulkhead, each 4 by 6 feet, inside measurements. The entrance to the outlet conduit is in excavation with a side slope of $1\frac{1}{2}$ to 1, the bottom and sides being paved with 12 inches of hand-placed riprap. The partition timbers are 12 by 12 inches, hewed, and are secured to each other by $\frac{3}{4}$ and 20 inch drift bolts at intervals of 5 feet. Sheet piling was driven against the bulkhead around the entrance of the conduit so as to prevent undermining of the bulkhead. This piling was 6 by 12 inches, formed by

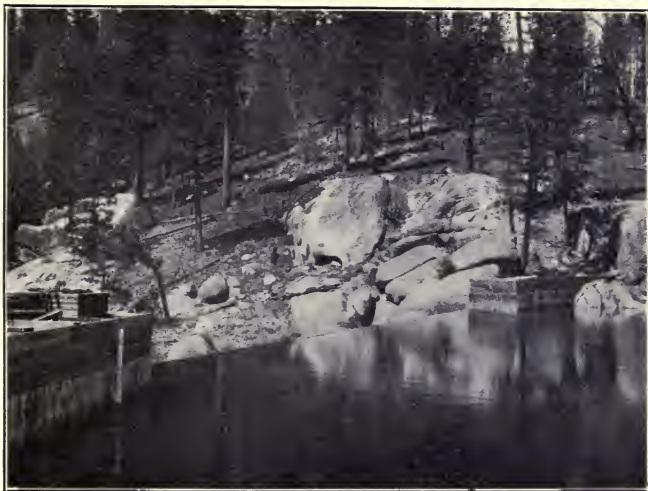
heavy grade of roofing paper to increase the imperviousness. At both ends of the dam bulkheads consisting of cribbing were built up about 7 feet above the crest of the dam and well anchored to the bedrock. These bulkheads were then faced with planking and filled with loose rock, adding to the stability. (Pl. V, fig. 1.)

FIG. 1.—BULKHEADS AND CREST OF SPILLWAY, FROM UPSTREAM SIDE, LYONS DAM, CAL.

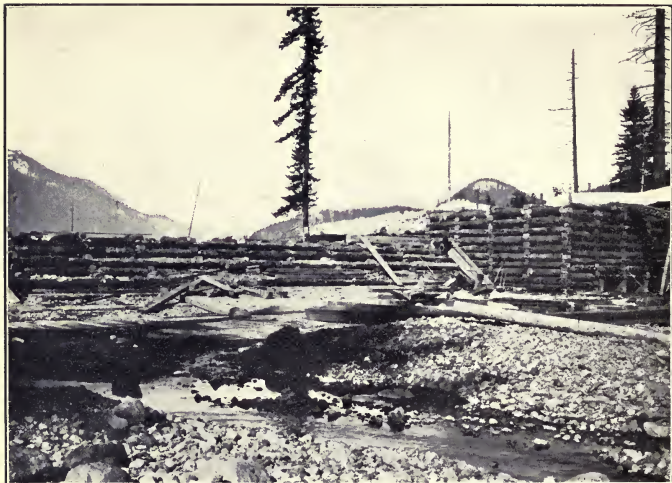
FIG. 1.—LAKE KEECHELUS CRIB DAM DURING CONSTRUCTION, DOWNSTREAM VIEW.

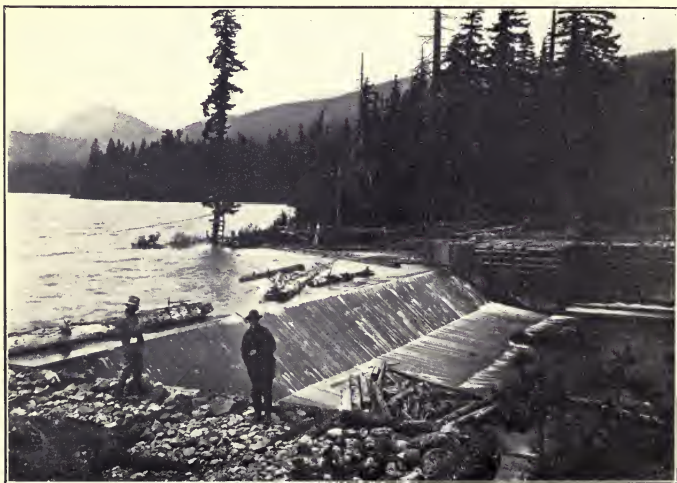
2-inch planks, tongue and groove, and had an average penetration in the soil of 9 feet. The completed dam is seen in Plate VI, figure 2, showing the bulkhead with the sheathing partially finished. The location of the outlet is indicated in the picture by two white streaks, caused by the outrushing water. It is also shown in figure 12. The conduits are roofed over by hewed timber laid transversely across partitions and sides, the minimum thickness of these timbers being 8 inches.

FIG. 2.—THE COMPLETED DAM, LAKE KEECHELUS, WASH., SHOWING SPILLWAY AND BULKHEAD.

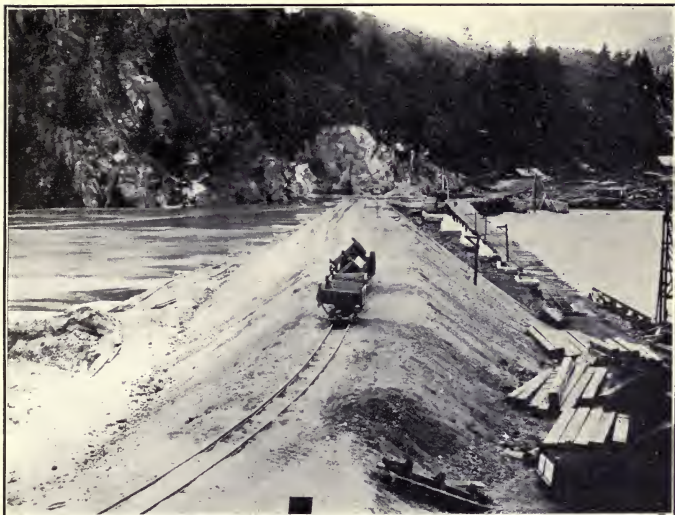
FIG. 1.—METHOD OF CONSTRUCTING EARTH FILL AT END OF CRIB DAM, CANYON FERRY DAM, MONT.

height of $12\frac{1}{2}$ feet above its crest or flow line. On the east bank an earthen dam 285 feet long with a masonry core wall and slopes of 2 to 1 and $1\frac{1}{2}$ to 1, respectively, on the upstream and downstream sides, was built to the hillsides. (Pl. VII, fig. 1.) The top of the dam is at the level of the top of the abutments.

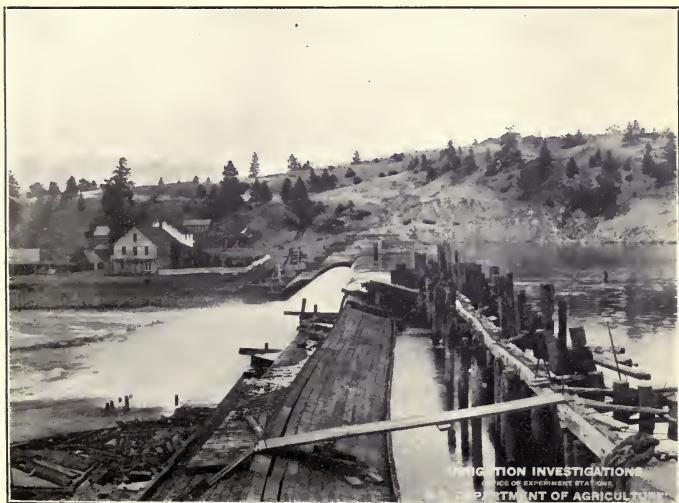
FIG. 2.—CANYON FERRY DAM, BEFORE RECONSTRUCTION.

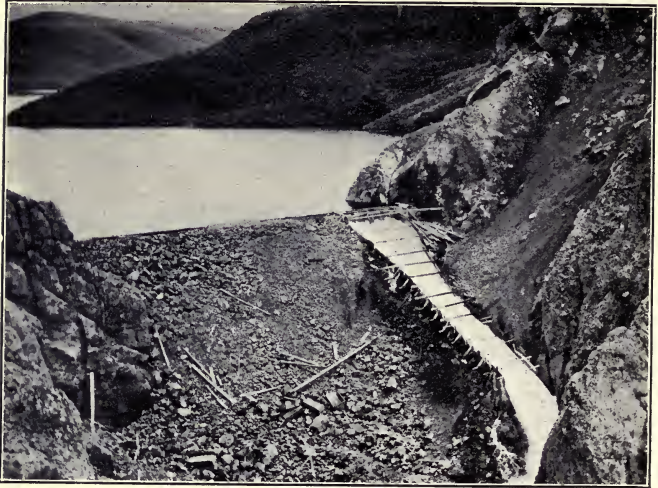
FIG. 1.—EAST CANYON DAM, UTAH, SHOWING TEMPORARY SPILLWAY.

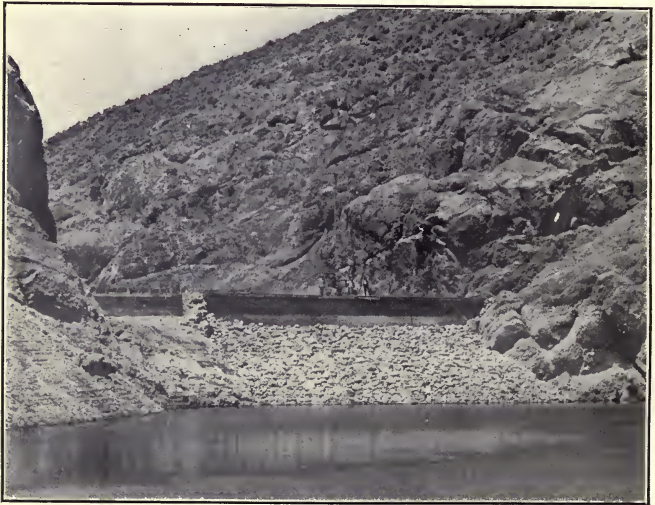
FIG. 2.—SAME, SHOWING STEEL CORE PROJECTING, AND SPILLWAY ON LEFT, AUGUST, 1900.

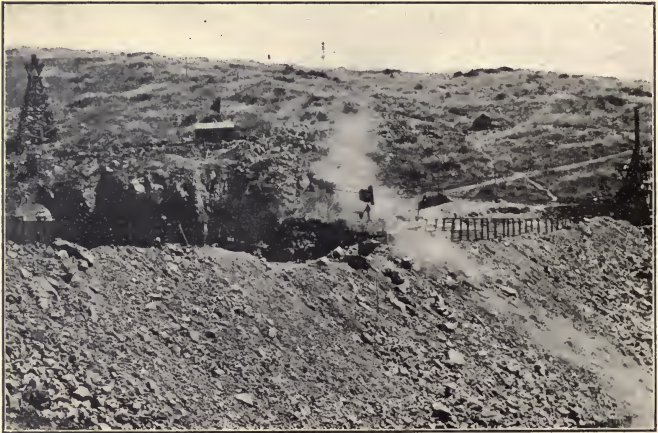
FIG. 25.—Lower Otay Dam—two cableways delivering rock from quarry.

A loaded skip would be handled in the following manner: First, the derrick would pick up the loaded skip and set it down under cableway No. 1 and take an empty skip back to be reloaded. Cableway No. 1 would then hoist the load and carry it on the dam, where

the chains would be unhitched from this and hitched to an empty skip to be taken back to the quarry. Cableway No. 2 would then hoist the load, carry it wherever needed, spill it, and set the skip back under cableway No. 1 before the latter had returned with another load. In this way the cableways and derrick would all be at work without interfering with each other. As high as 225 loads were handled in 10 hours, and the daily average of 200 loads was made for several weeks at a time. This number could have been increased if the quarry had been above the top of the dam. In the present case the level of the bottom of the quarry was but 20 feet above the base of the dam. The time consumed in hoisting and lowering was equal to one-fifth of the time taken to handle a load from the quarry to the dam.

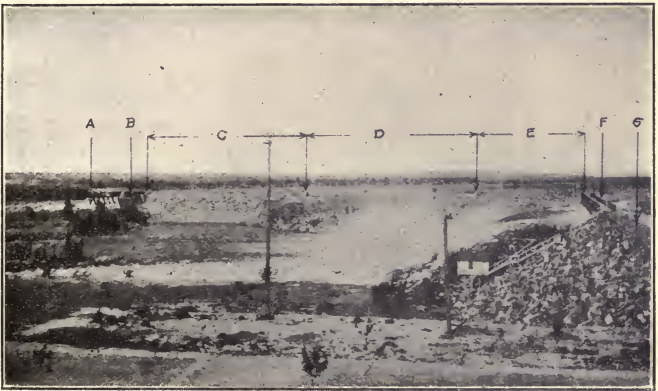
FIG. 28.—General view of Milner Dam, Snake River, Idaho: A, Control or wastegates on canal; B, Headgates, North Side Canal; C, North dam, length 340 feet on top; D, Spillway, concrete apron; E, Middle dam, length 335 feet on top; F, Regulating gates (99); G, South dam, length 560 feet on top. Total length of structure 2,100 feet.

figure 28 gives a general view from the downstream side. The general plan of all these dams was practically the same, but in constructing the main-channel dam the work was rendered more difficult owing to the necessity of handling the low-water flow of the river. The south and middle dams were constructed first, and, being located in channels which were dry except at periods of high water, their construction was comparatively easy.

In the general view of this dam (fig. 28, p. 53) already referred to, the headgate of the North Side Twin Falls Canal is shown at B. Similar headgates of the South Side Twin Falls Canal are shown more in detail in figure 31.

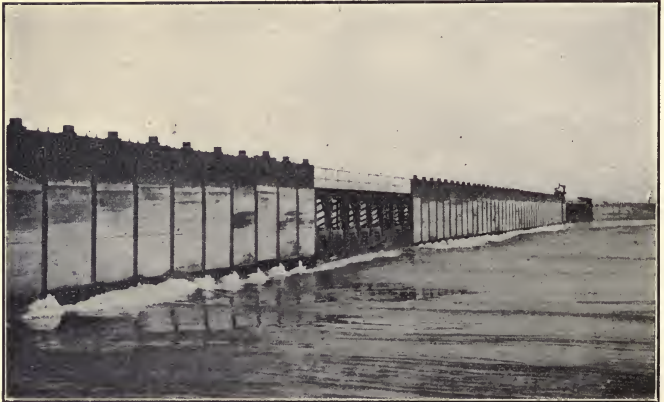
FIG. 29.—Gates in Milner Dam, Snake River, Idaho. At times of high water these gates are raised to regulate flow in canals.

Before building the north or main-channel dam it was planned to cut a tunnel through the point of the south island of sufficient size to carry the low-water flow during construction. This tunnel consisted of eight sections, each 5 feet wide and 9 feet high. The flow of water was controlled by heavy cast-steel gates, raised by geared stands. (Figs. 29, 30.) Quoting from Schuyler's work, already referred to:

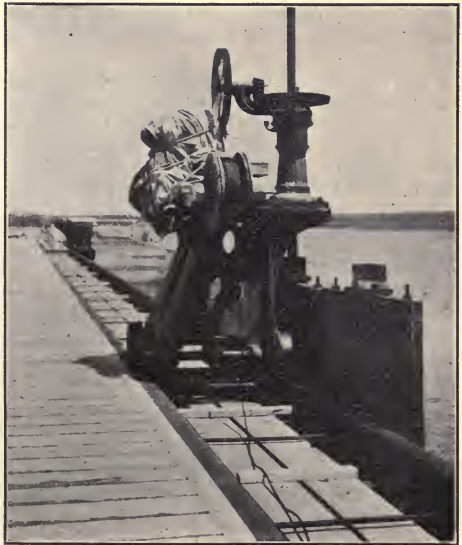
FIG. 30.—Milner Dam, showing lifting apparatus operated by electric motor.

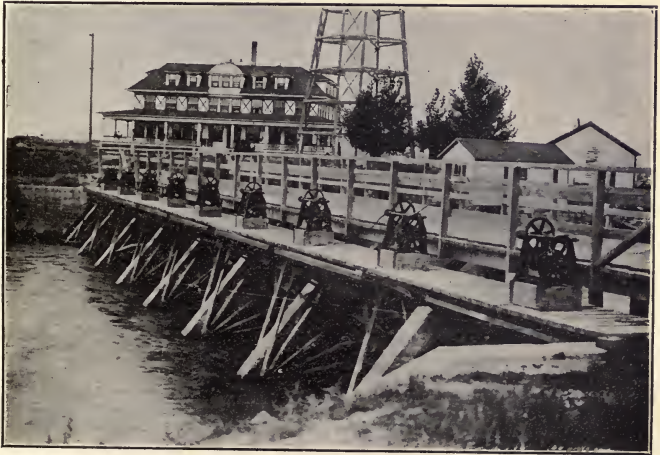
FIG. 31.—Headgates, Twin Falls Canal system, South Side, at Milner, Idaho.

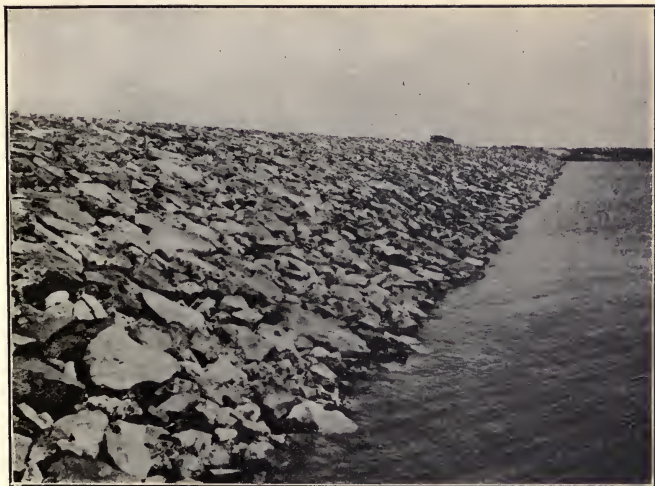
FIG. 33.—Riprapped slope, Minidoka Dam, Snake River, Idaho.

The main dam is of the loose-rock-fill type, with a concrete core back filled on the upstream slope with earth and gravel. This slope has a heavy gravel face protected by cyclopean riprap (fig. 33).

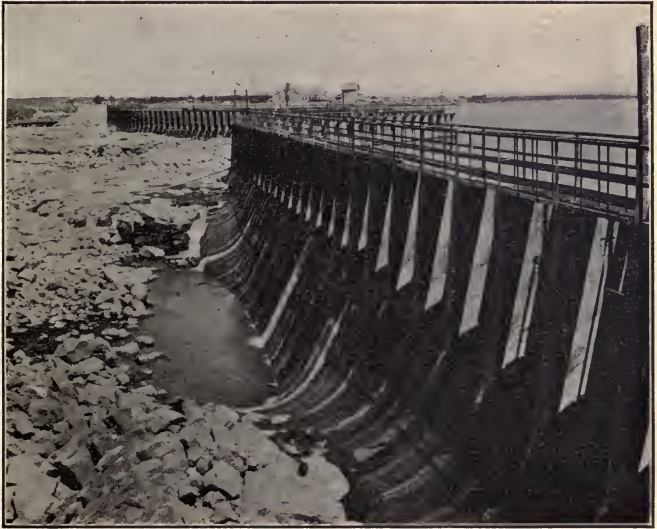
FIG. 36.—Spillway, Minidoka Dam, Idaho (U. S. Reclamation Service).

spillway (fig. 36), 2,385 feet long, was built at the south end of the dam, following the highest ridges of rock. The excavation for the

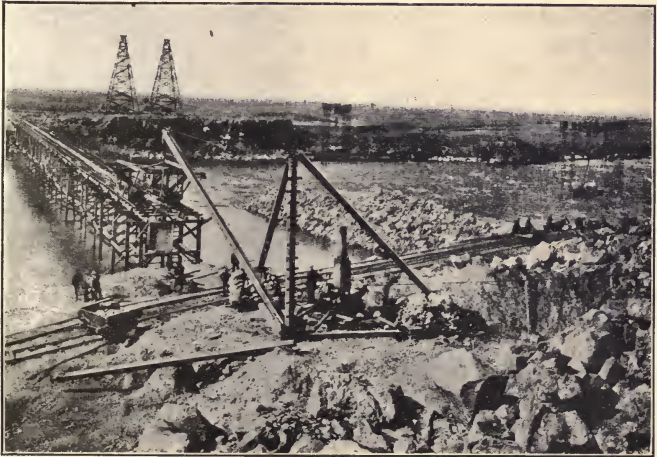
FIG. 38.—Showing derrick handling skips, and cableways in action; also showing double trestle from which earth was dumped in the back-filling, Minidoka project, Idaho (U. S. Reclamation Service).

For the purpose of placing the earth-gravel back filling in the dam a double trestle (fig. 38) was built across the river and tracks
